# Walk Around

## F-8 Crusader

Walk Around Number 38  
squadron/signal publications

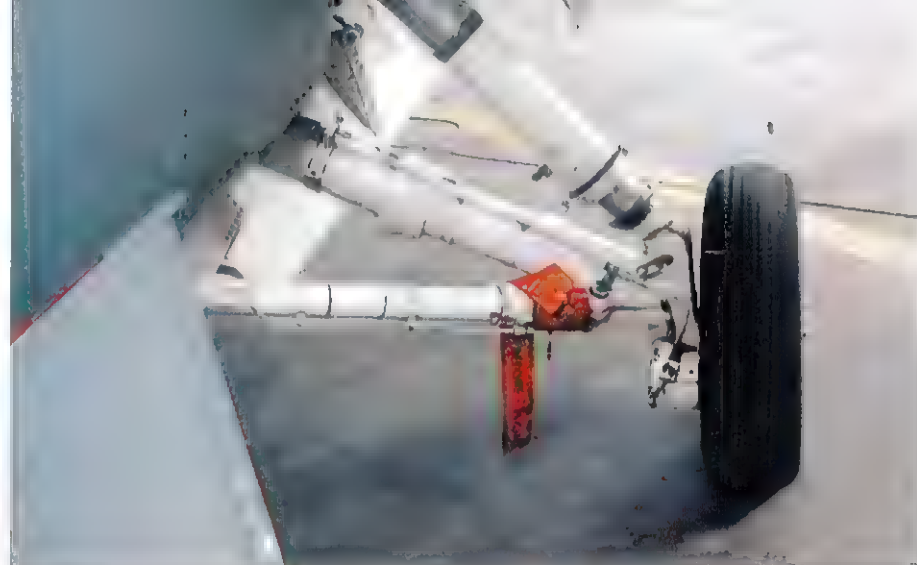
The F-8's tricycle landing gear was housed completely within the fuselage when retracted. The main landing gear consisted of a tension strut (the lower large diameter arm), an oleo-type shock strut (the larger diameter upper arm), and a combination drag strut/actuator cylinder. The latter was attached to the tension strut's lower aft end. (Weinel)

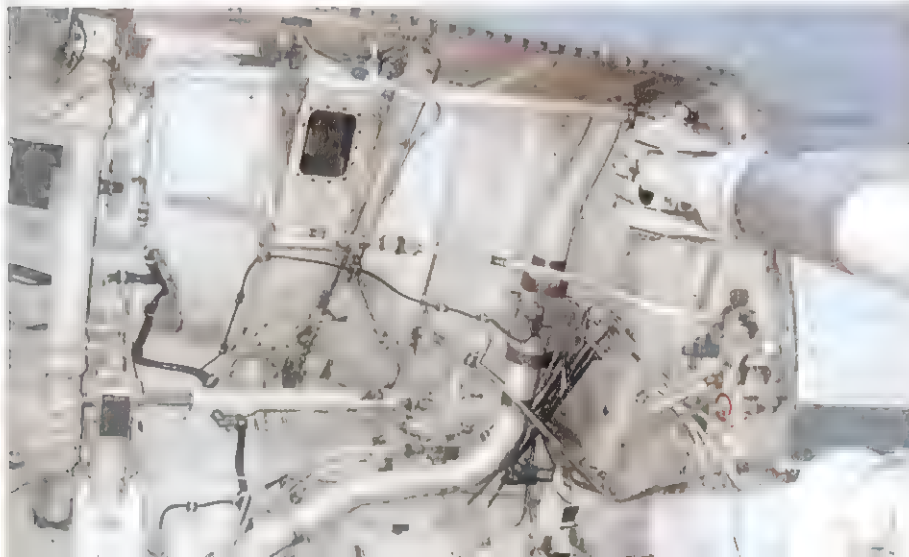
The main difference between the right and left wells was that the left well contained the fueling system controls. The central fueling point adapter was located on the main fuel line. This adapter had a Dark Gray cover, with a center-mounted Bright Red information plate. The engine compressor inspection port and the fuelling procedure selection switch were located in the left well. (Weinel)

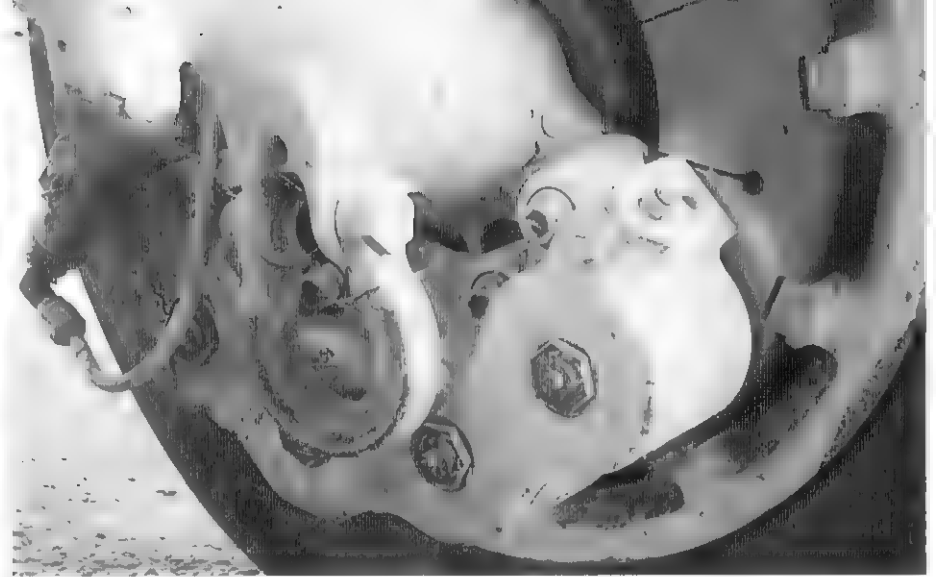
The F-8 was equipped with hydraulically actuated disc brakes. The four cylindrical brake 'puck' pads were mounted on the main tension strut's lower inner face. A tie down ring for securing the aircraft to the deck was located just aft of the brake assembly. A jack pad boss was located just above this tie down ring. (Nick)

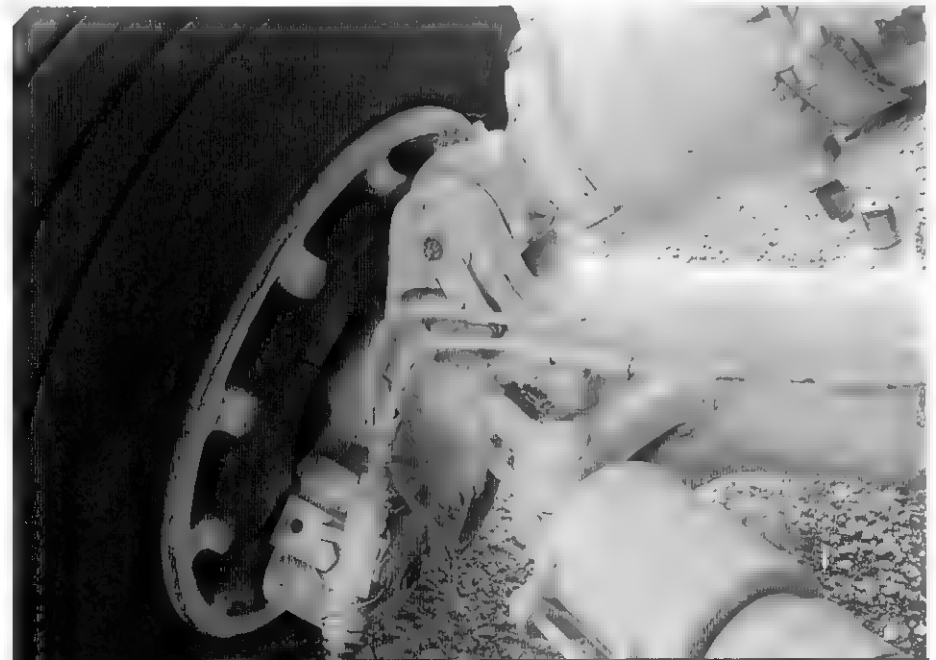
The landing gear shock strut and actuator cylinder were connected to the main tension strut's outer end. Hydraulic brake tubing ran along the main tension strut. This was because the strut's length would not vary as the gear was compressed or extended, unlike the shock strut and actuating cylinder. (Nick)

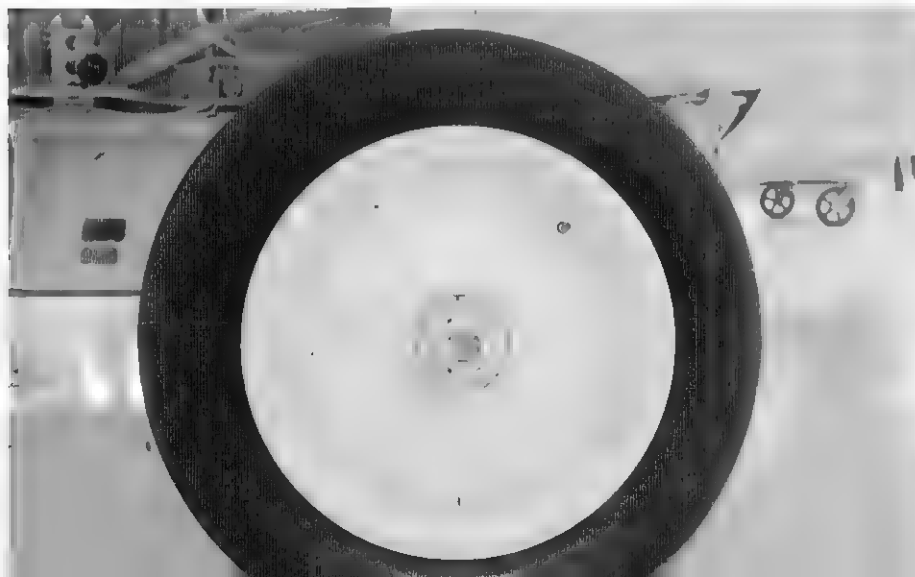
The landing gear actuator door was mechanically linked to the landing gear extension cylinder and extended or retracted with the cylinder. Hydraulic supply and return lines connected to both rigid cylinder housing's ends provided power to the extension cylinder. (Weinel)

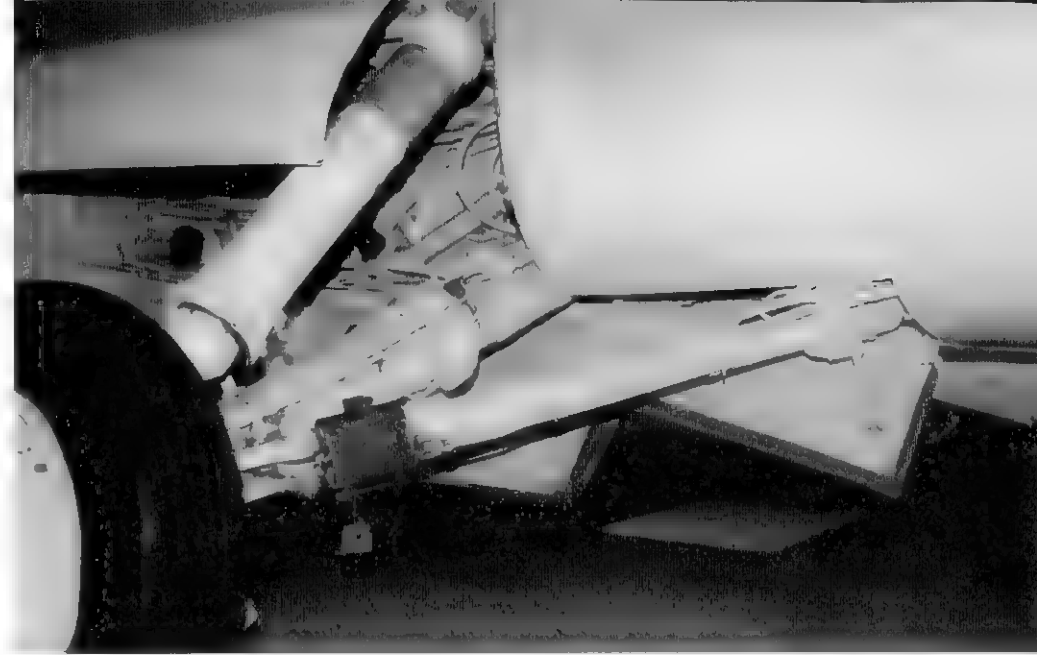
A bell crank arm connected the upper main landing gear door to the gear actuator. The hinge mechanism ran the full length of the door and was connected to the fuselage well longerons. Landing gear door edges were painted Bright Red (FS31136) on Crusaders and other US Navy aircraft. (Weinel)

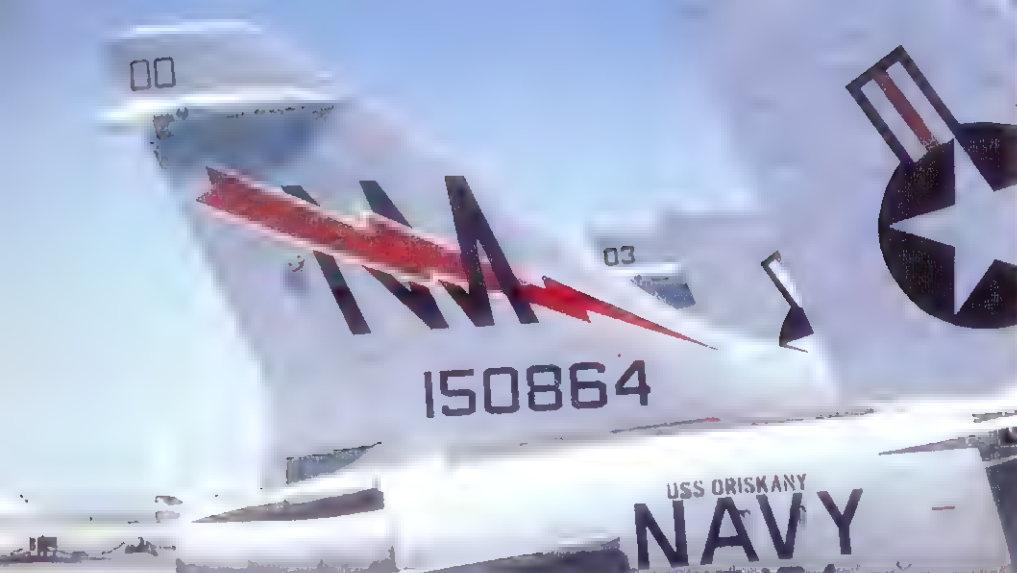
Increased longitudinal control was required with the lower landing speed of F-8s equipped with the dual droop wing. This was obtained by increasing the Unit Horizontal Tail (UHT) surfaces' area. Structural reinforcement was added to the rudder and leading edge hinges on high hour airframes. The rectangular wing fuel dump vent was located just ahead of the wing tip formation light on each wing's undersurface. (Trombecky)

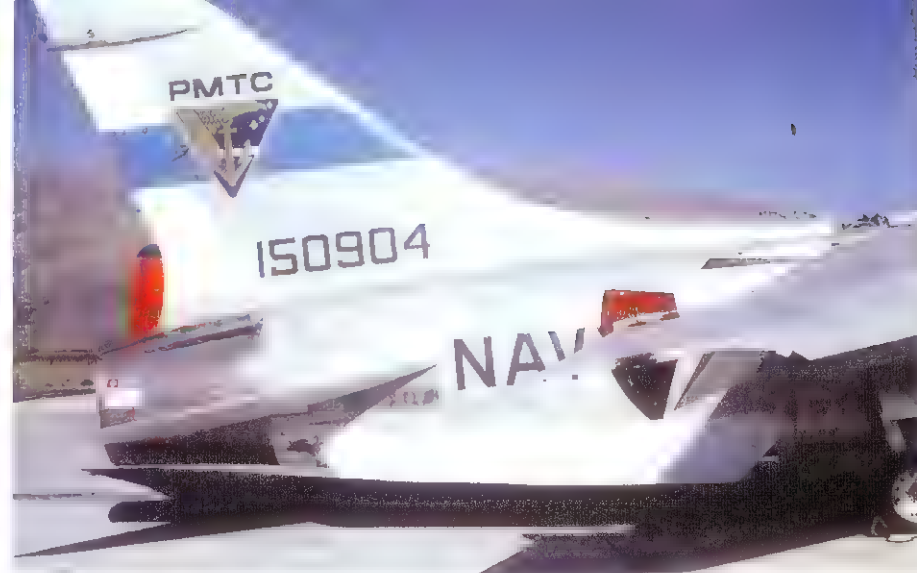
Installing a cuff over the existing UHT's leading edge increased its area. This effectively moved the leading edge 4 inches (10.2 cm) forward at the inboard end of the surface and faired it in with the exiting tip casting's leading edge. The dual droops are extended on this F-8J Crusader's right wing. (Trombecky)

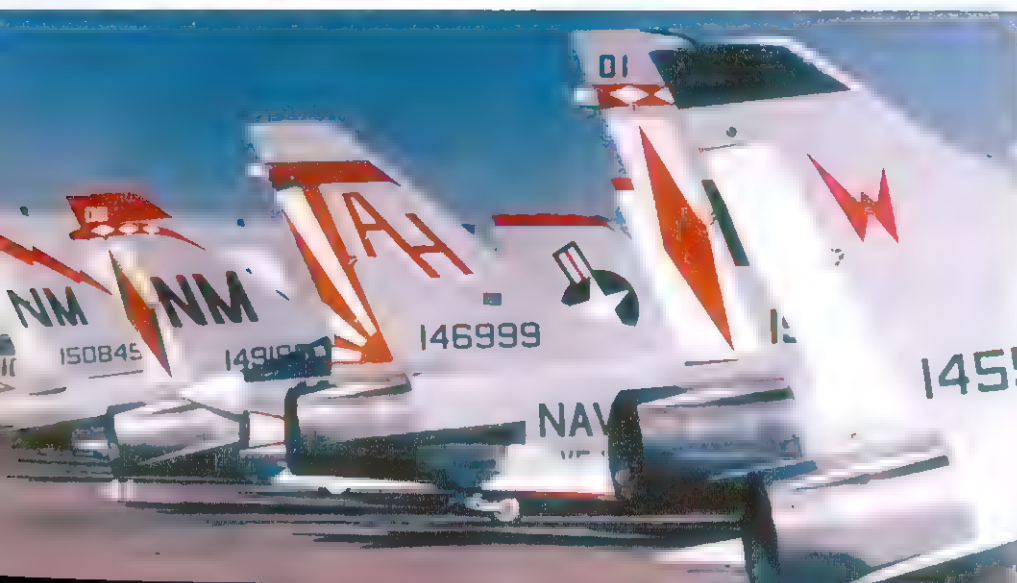
Early J57 engines through the F-8A/B's J57-P-4 employed a convergent/divergent nozzle. This nozzle was aft of the afterburner section and consisted of eight individual nozzle flaps. The flaps were cast titanium plates with square 'waffle' pattern reinforcing ribs. (Nick)

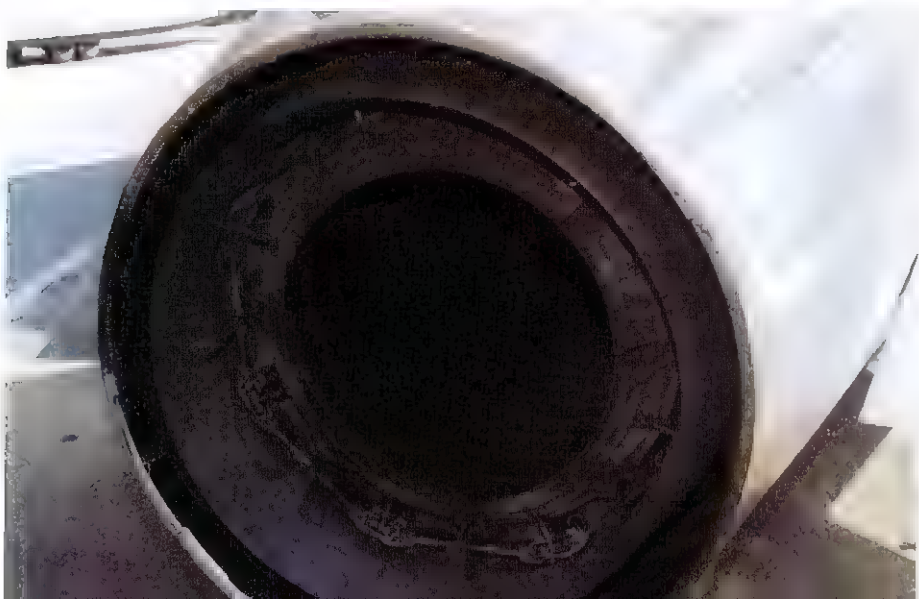
The exhaust nozzle area was automatically increased for afterburner operation. Eight flap actuator cylinders mounted in the fuselage tail cone adjusted the nozzle area. These were mechanically linked to the exhaust nozzle flaps and held the flaps open during afterburner operation. (Nick)

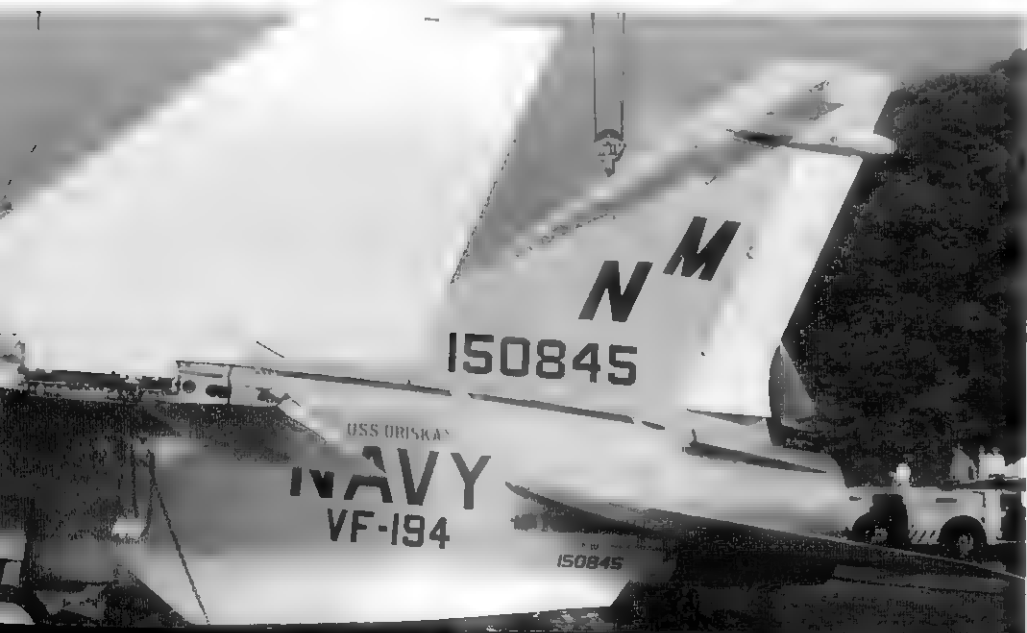
Two engine compartment cooling vents were located on the right fuselage just forward the aft fuselage separation line at fuselage station 595. These vents were not on the left fuselage side. The aft section removal access door was the square panel at the top of the letter 'V.' (Dann)

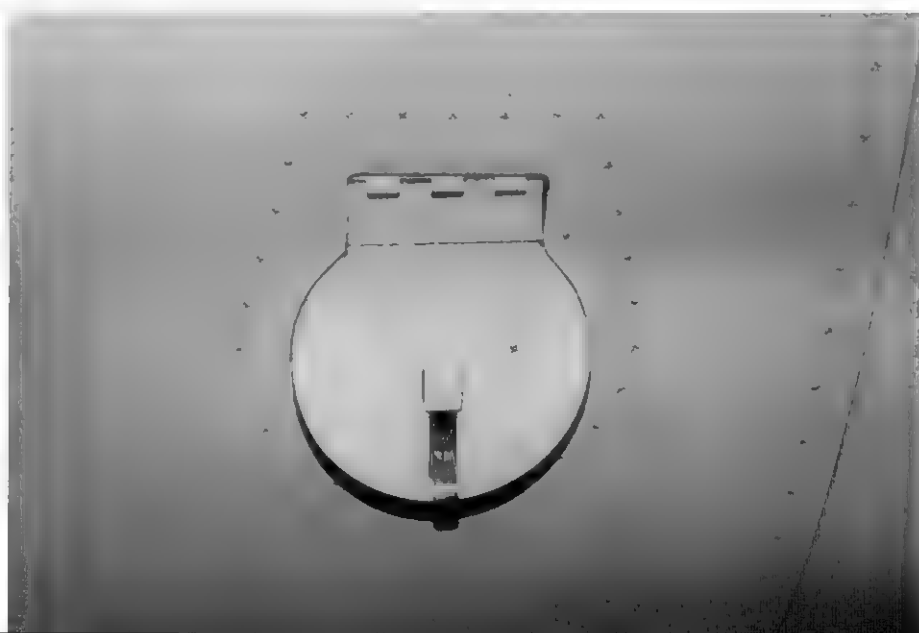
All F-8s were equipped with four circular spring-loaded engine compartment cooling vents – two on each side. These vents were located just forward of the titanium tail cone near the rudder's base. The vents were spring-loaded closed and opened by negative engine bay pressure generated while at low power settings. (Author)

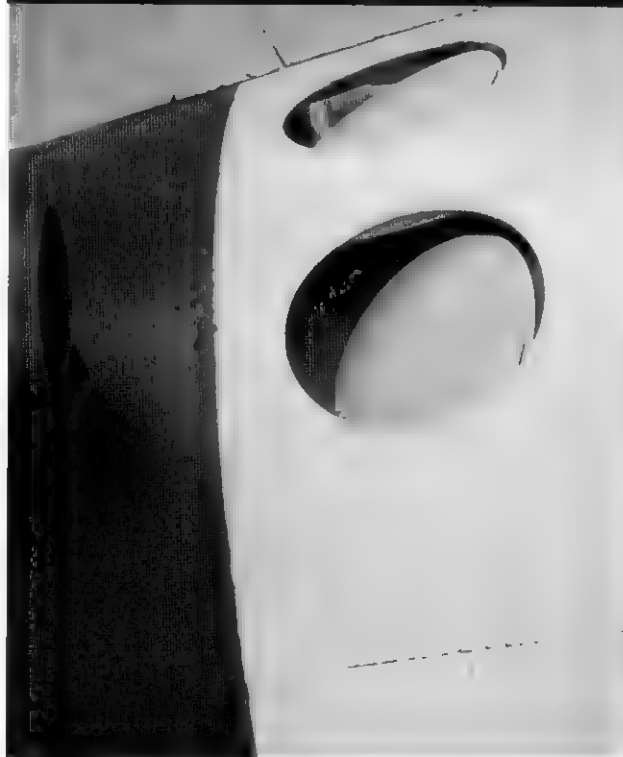
The right side rudder hinge was located at vertical tail station 181 and connected to the rudder control main spar. Elongated slots in the vertical stabilizer's right side opening accommodated rudder movement. The connecting clevis fitting's centerline was offset to the right of center for interfacing with the actuator mount. (Author)

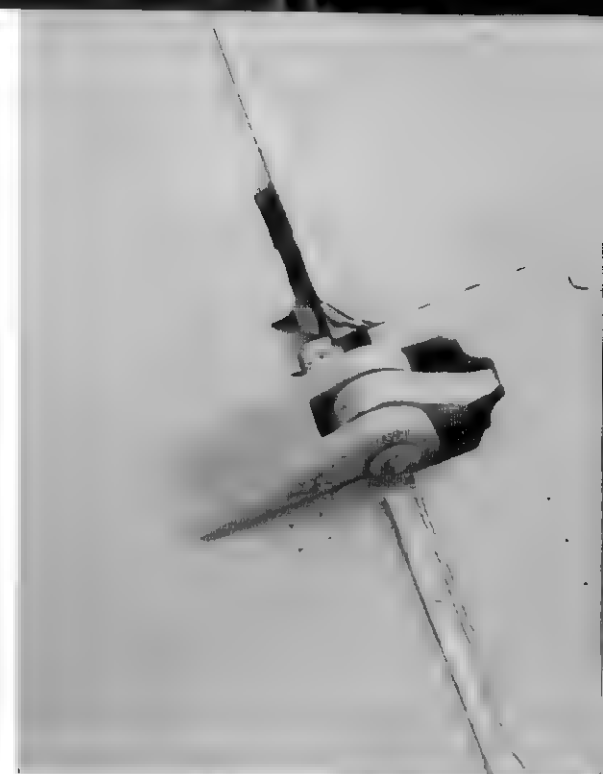
The left side rudder main hinge differed slightly from the right side. The vertical stabilizer's opening was smaller due to the actuator connection's location. A flexible seal in the vertical stabilizer's trailing edge reduced buffeting at the fin-to-rudder interface. (Author)

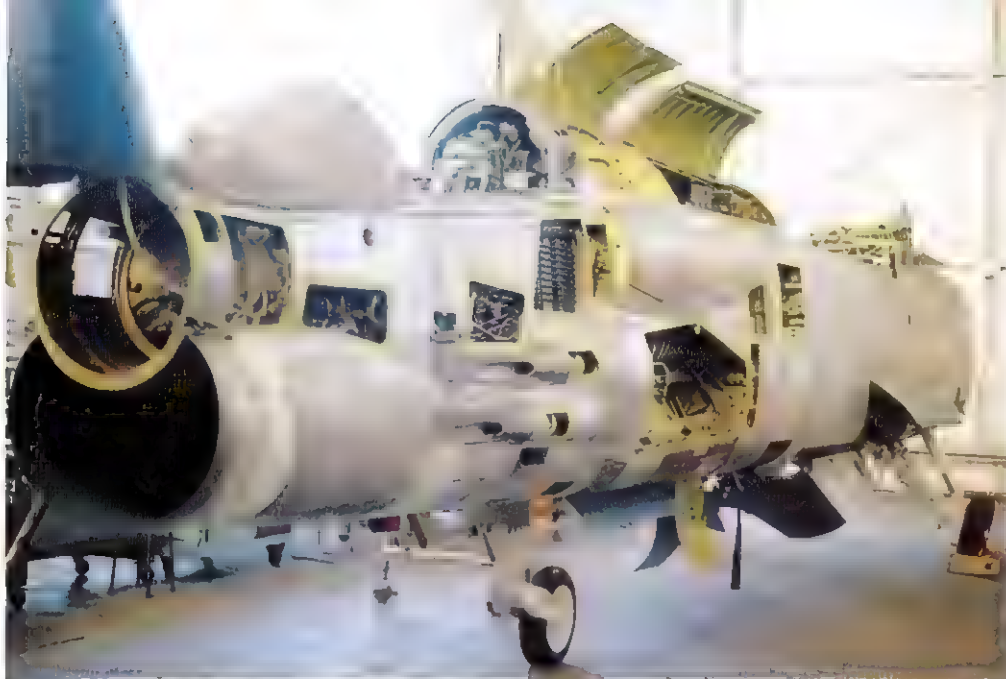
The *Aéronavale* authorized the final upgrade program for its 17 remaining F-8E (FN)s in 1989. Between 1990 and 1997, one Crusader completed the *Prolongué* (Prolonged) modifications every 18 months. These modifications included a complete wiring replacement, installing an improved Instrument Landing System (ILS), adding the Mode 4 Identification Friend or Foe (IFF) system, a new Inertial Navigation system (INS), and integrating the SHERLOC Radar Warning Receiver (RWR). The Martin-Baker Mk-F7 ejection seat replaced the Mk-F5A from July of 1994. These Crusaders were re-designated F-8E (FN) Ps. (Gail)

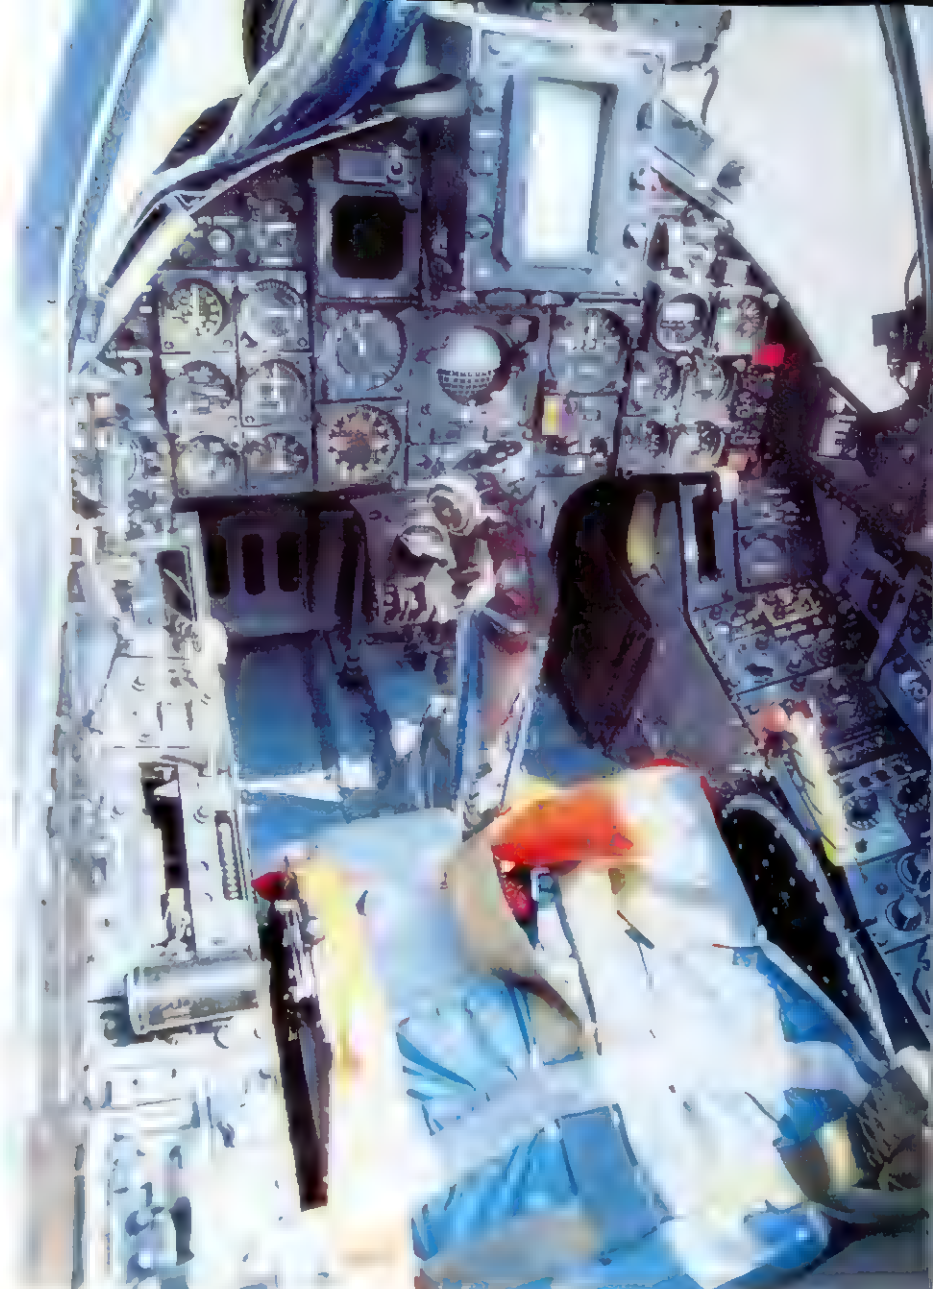
The F-8E (FN) P cockpit differed slightly from the original *Aéronavale* aircraft. The main differences were adding the SHERLOC RWR screen left of the AN/APG-104 radar scope and the improved ILS display. After July of 1994, the 'P' also received the Martin-Baker Mk-F7 ejection seat with a French survival pack. This seat replaced the Martin-Baker Mk-F5A seat originally installed on French Crusaders. (French Navy)

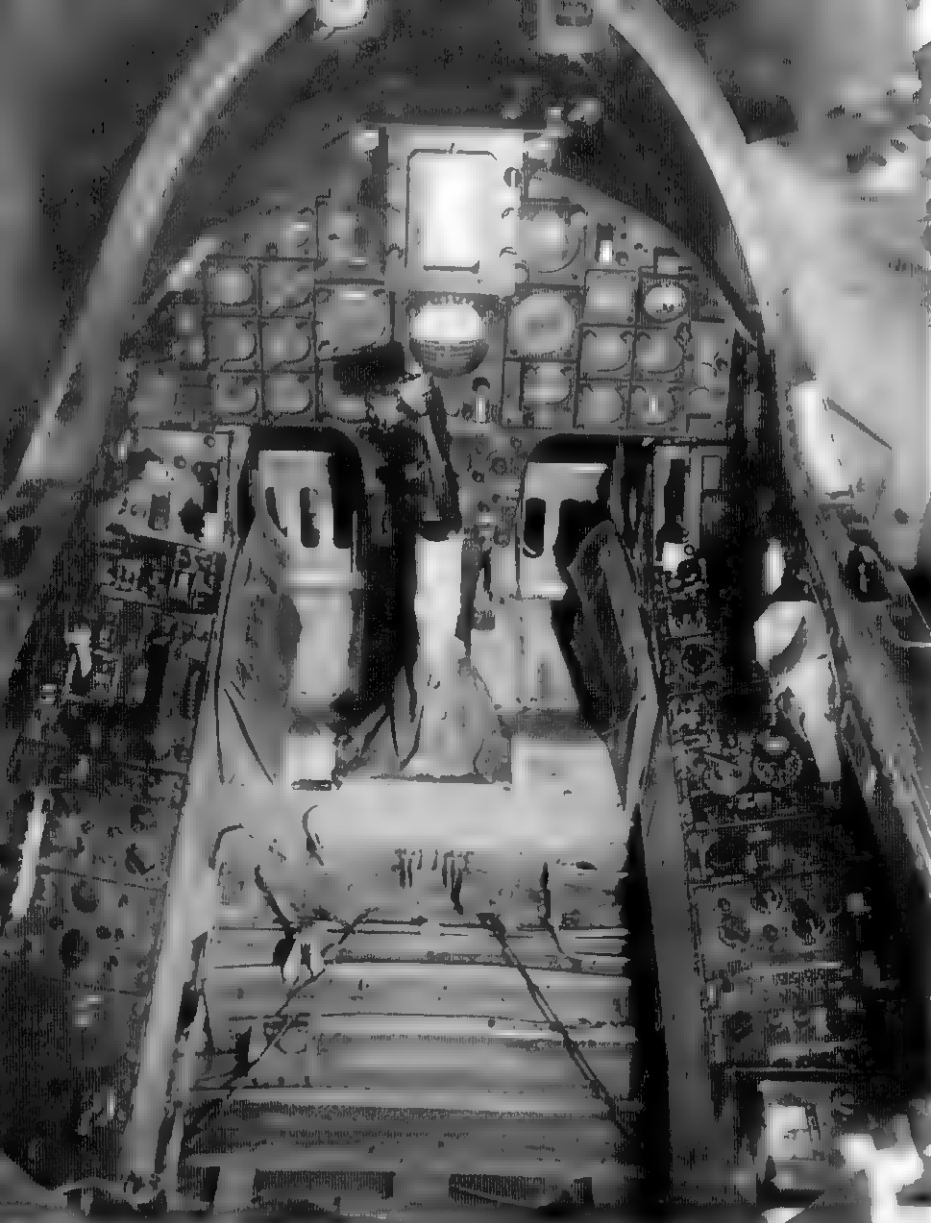
The original French Crusader's cockpit layout was basically identical to the US F-8E, except for the added BLCS controls. The F-8E (FN) had a 5-inch (12.7 cm) tall screen for the Magnavox AN/APQ-104 radar. Removal of the ejection seat exposed the intake trunk roof that formed the cockpit floor. All Crusaders had the foot well recessed in the front cockpit, which provided additional clearance for the pilot. (Gall)

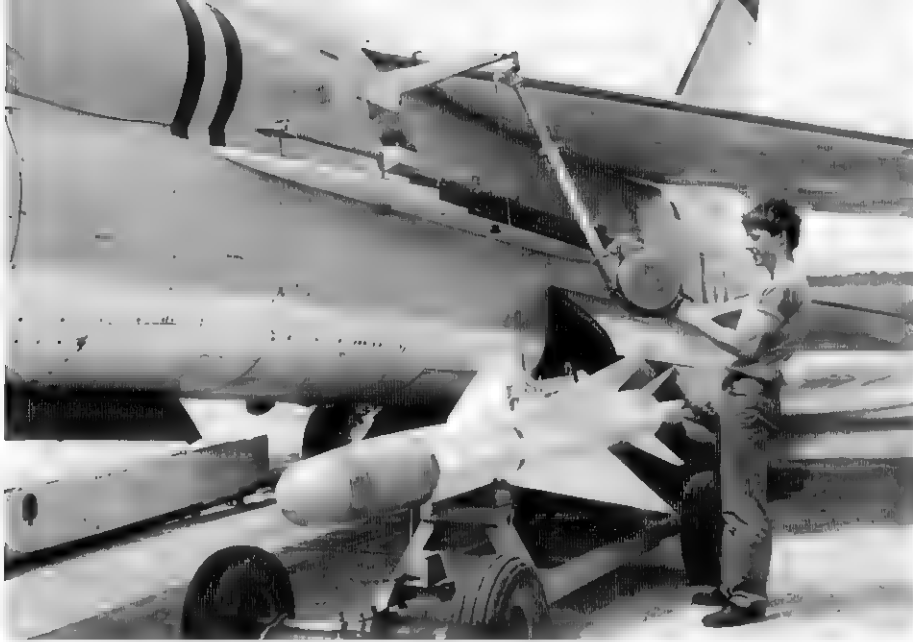
The F-8E (FN) was capable of carrying the Matra R.530 AAM, which a ground crewman is loading on this Crusader (11) using a winch fitted to the aircraft. French Crusaders carried two R.530s – one on each fuselage side. The 65 percent failure rate led the French Navy to abandon this missile in 1991. The R.530 was 11 feet 2.4 inches (3.4 m) long, 9 inches (22.9 cm) in diameter, and weighed 425 pounds (193 kg). (French Navy)

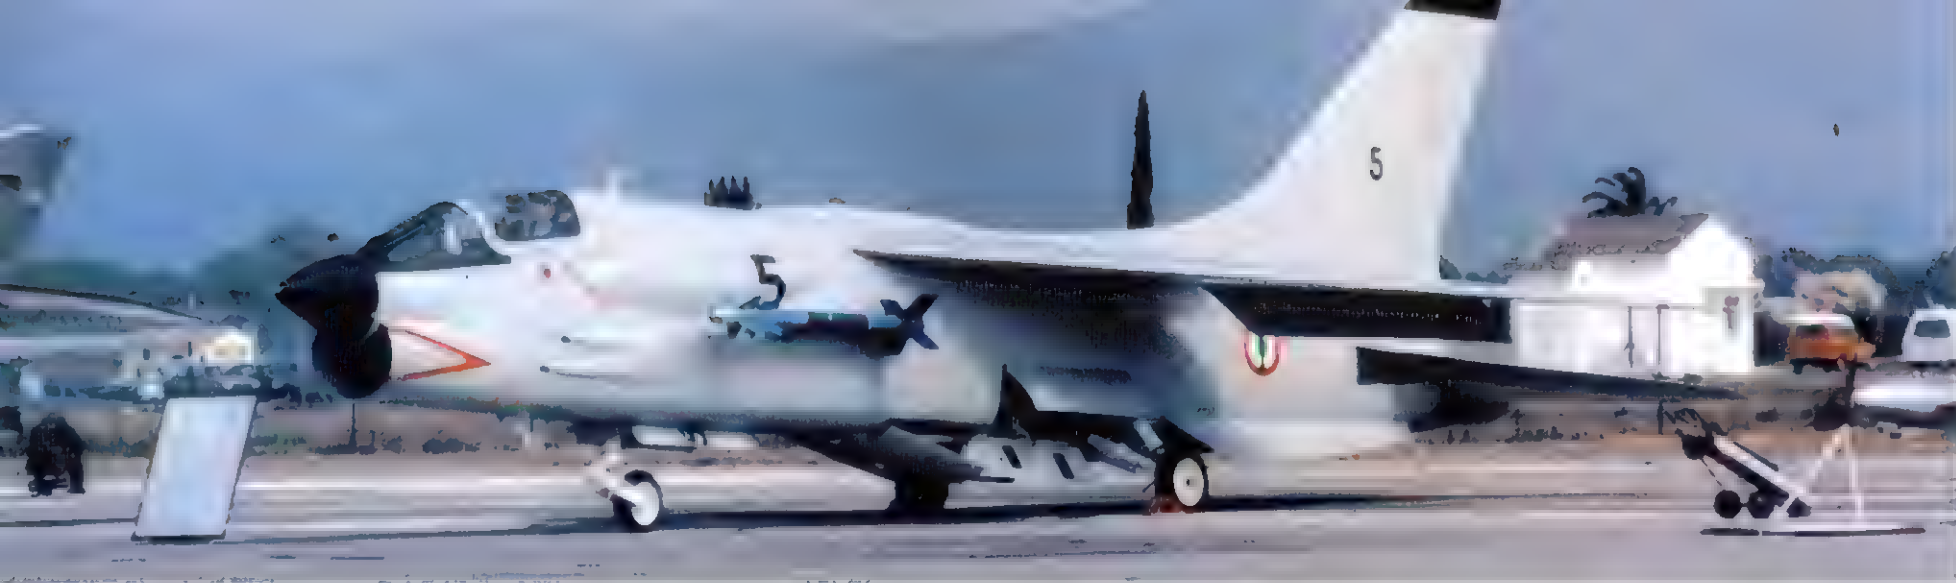
An overall Light Gull Gray F-8E (FN) (5) is displayed at a French air base. A Blue Matra 550 Magic Infrared (IR) AAM is mounted on the left 'cheek' pylon; operational missiles were overall White. The *Aéronavale* used the Magic in place of the AIM-9 Sidewinders that armed US F-8s. The Magic is distinguished by the two sets of canard (forward) fins just

aft of the nose. This missile is 108.2 inches (275 cm) long and weighs 198 pounds (90 kg). The *Aéronavale* roundel was painted on the aft fuselage sides, upper left wing, and lower right wing. It had a Black anchor superimposed over the Blue (center), White, and Red French roundel, with a Yellow outer ring on this aircraft.

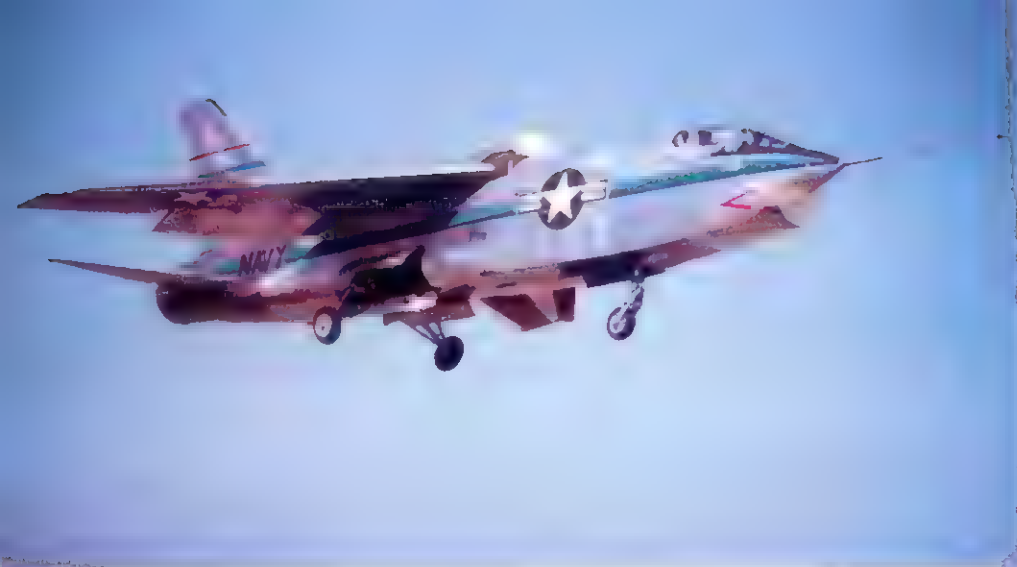
While F8U-1 fighter production began, Vought Initiated design proposal V-392 for a Crusader photo reconnaissance variant. The 32nd F8U-1 (BuNo 141363) was reconfigured as the XF8U-1P test platform. (The P suffix stood for photographic.) The reconnaissance Crusader was basically the same as the fighter from aft of the leading edge. The F8U-1P made its initial flight on 17 December 1956. (Vought)

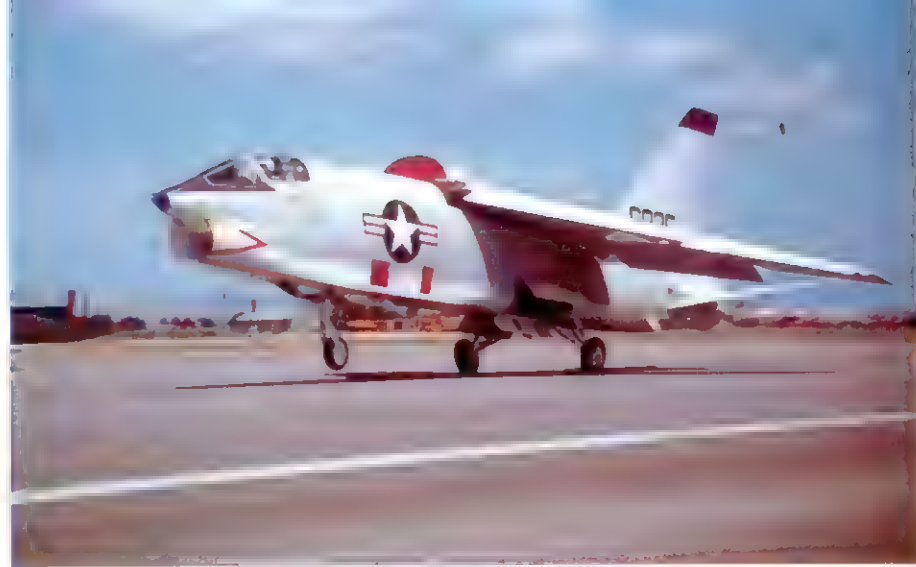
The F8U-1P (RF-8A from 18 September 1962) had squared-off fuselage sides, which provided flat surfaces for the electrically heated optical glass panels. These panels were required to yield the optimum photo quality. The flat sides were blended into the upper fuselage and curved intake air duct. Camera station 2L (2 Left) was located on the forward left fuselage. Station 3 was placed aft of 2L on the lower left fuselage. Red covers are placed over the camera windows for this test flight. (Vought)

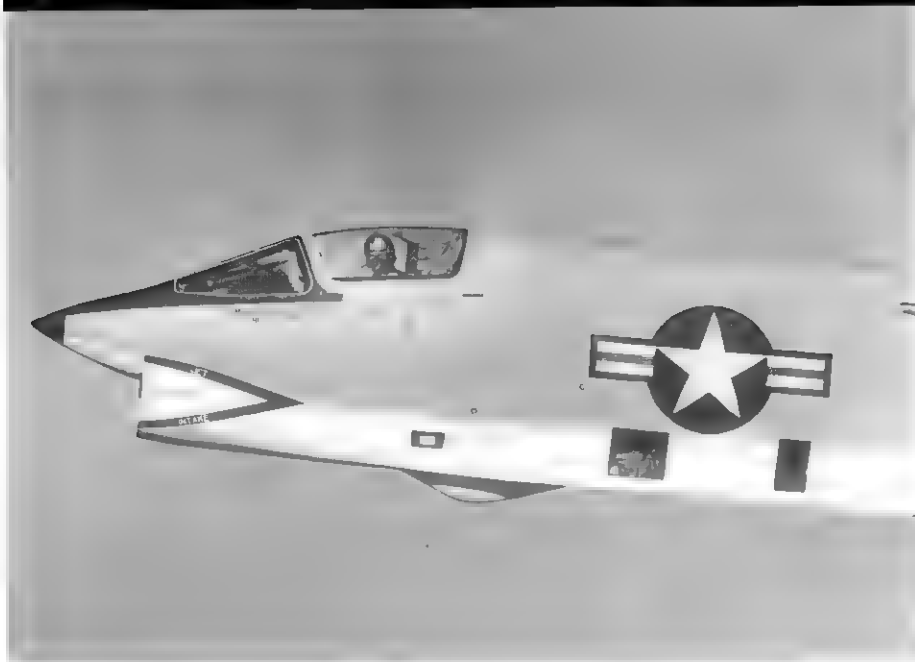
Major Glenn's F8U-1P flies beside a camera aircraft during Project BULLET in 1957. The area rule concept – minimizing transonic drag at zero lift – affected the F8U-1P (RF-8A) profile. The increased fuselage cross-sectional area caused by its flat sides deemed it necessary to add an upper forward fuselage 'hump.' The upper fuselage 'dipped' aft of the canopy and 'rose' again forward of the wing leading edge. (Vought)

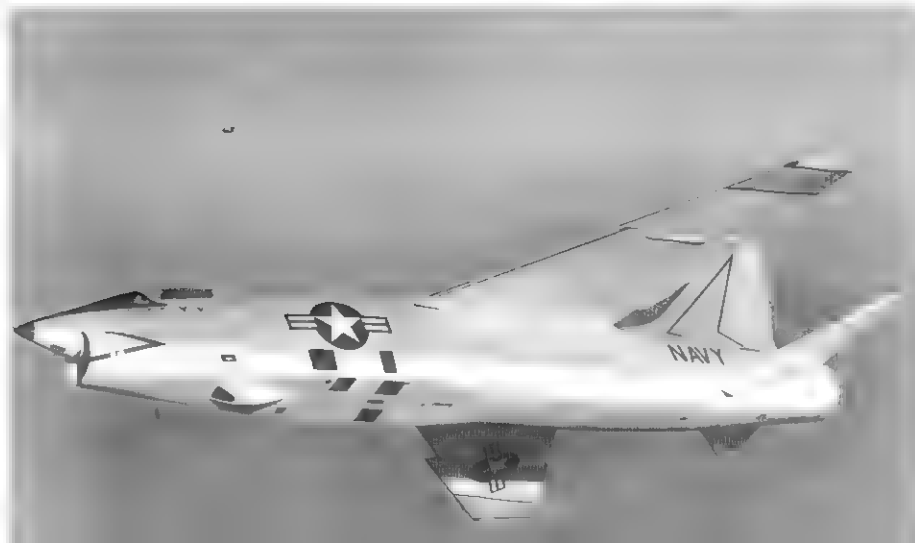
The flattened lower forward fuselage provided the optically flat surfaces required for the vertically mounted camera. The teardrop-shaped housing of camera station 1 was located just forward of the nose landing gear. The F8U-1P retained the F8U's central fuselage catapult attachment point – the slot aft of the lower camera windows – but was not equipped with the aft fuselage ventral strakes. (Vought)

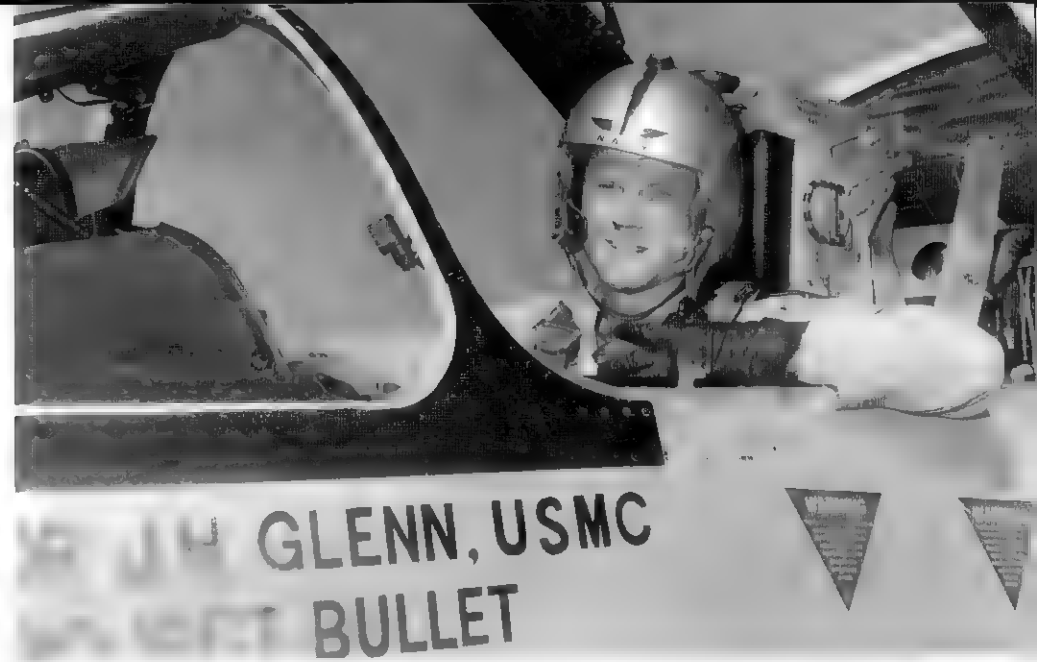
Glenn sits in the cockpit of his Crusader prior to his 1957 transcontinental record flight. The F8U-1P (RF-8A) was originally equipped with the same Vought-designed ejection seat as on early Crusader fighters. The reconnaissance variant's canopy latching hooks and sealing mechanism were also the same as on the fighters. (Vought)

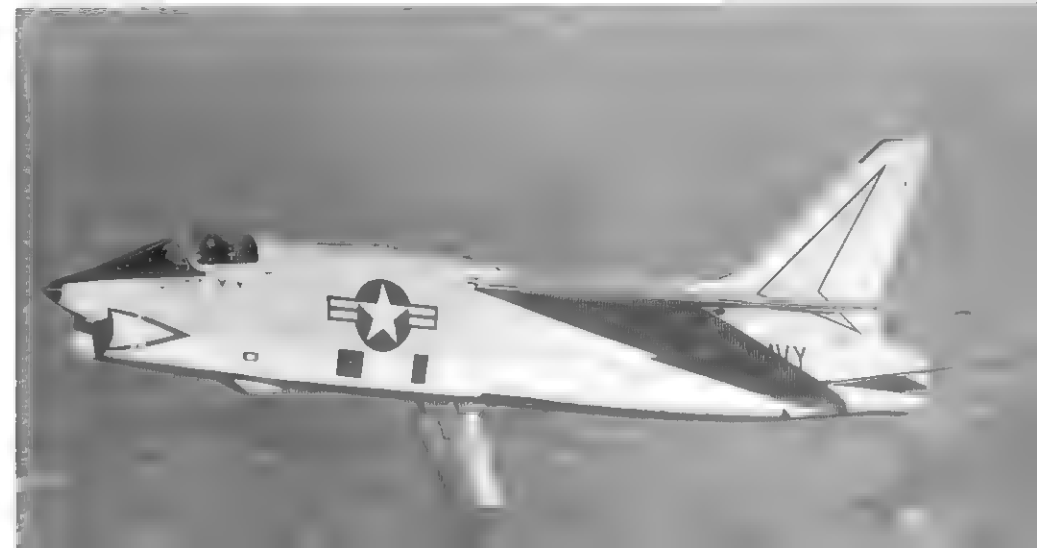
Major Glenn deployed the ventral speed brake from the F8U-1P's fuselage undersurface. This brake differed in design from those in the Crusader fighters because the rocket pack was not installed in the reconnaissance variant. The F8U-1P was also equipped with a fuselage fuel vent mast on the aft lower fuselage just ahead of and below the Unit Horizontal Tail (UHT). (Vought)

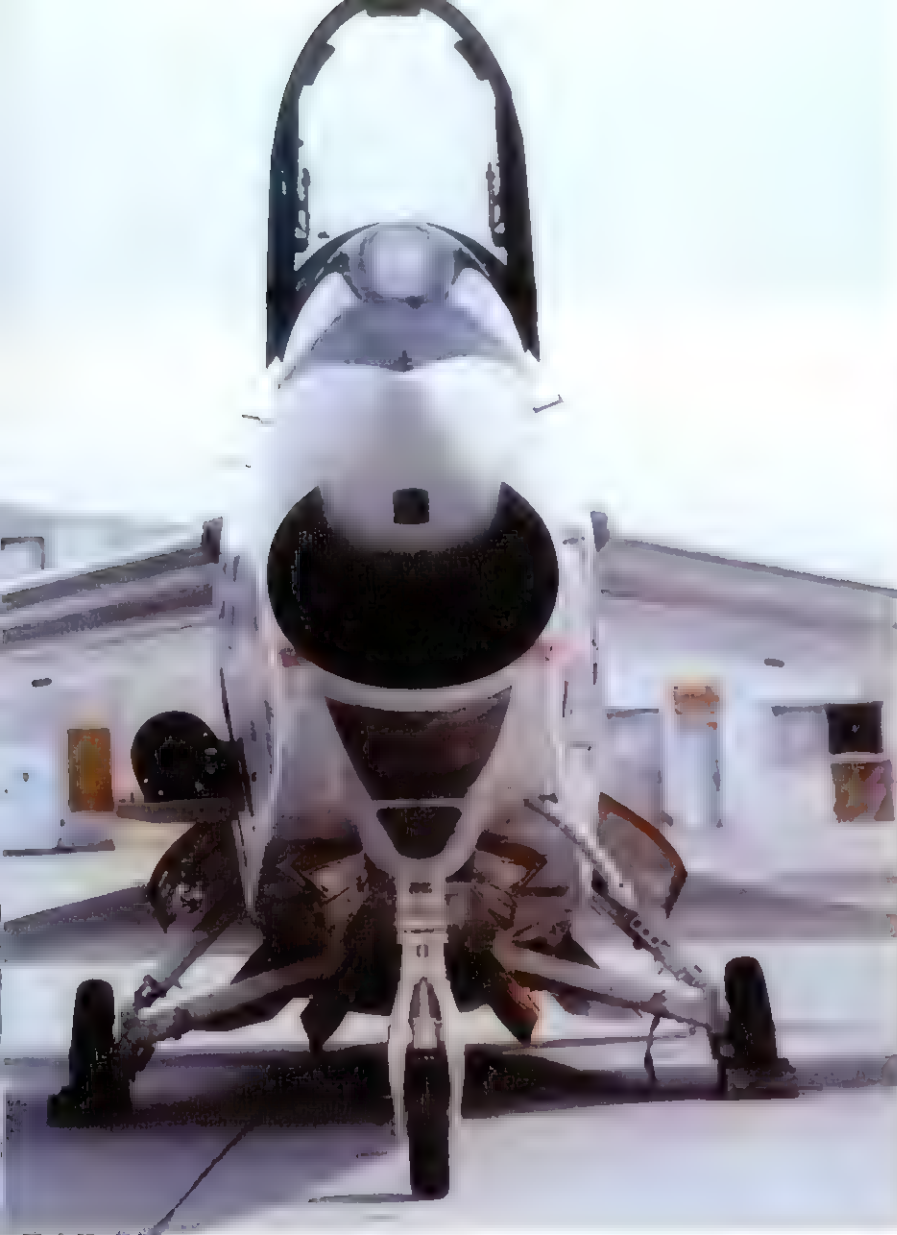
The lower air intake surface immediately in front of camera station 1 was often painted Flat Black (FS37038) to reduce glare on the camera lens. The viewfinder window was located in the nose cone at the 6 o'clock position. It provided the pilot with a view of the area being photographed by the oblique mounted camera in station 1 and the fuselage-mounted vertical cameras. (Trombecky)

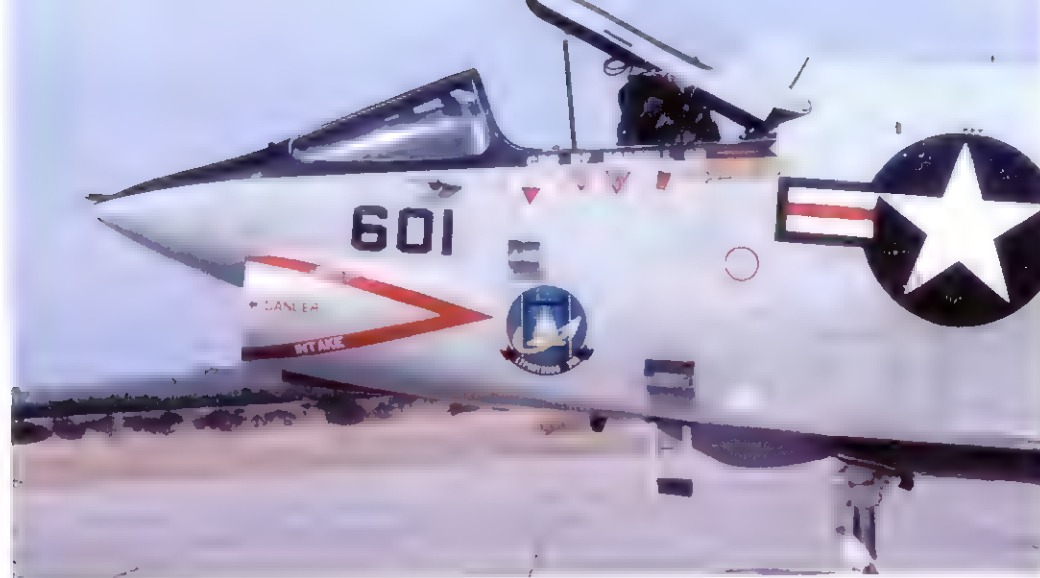
Lower, middle, and upper boarding steps are extended on this RF-8G. The reconnaissance variant's canopy hinge mechanism was identical to those on Crusader fighters. The Red In-flight Refueling Probe (IRP) illumination light was installed just in front of the Altitude Identification and Measuring System (AIMS) pitot tube, which was located just below the left windshield quarterlight. (Trombecky)

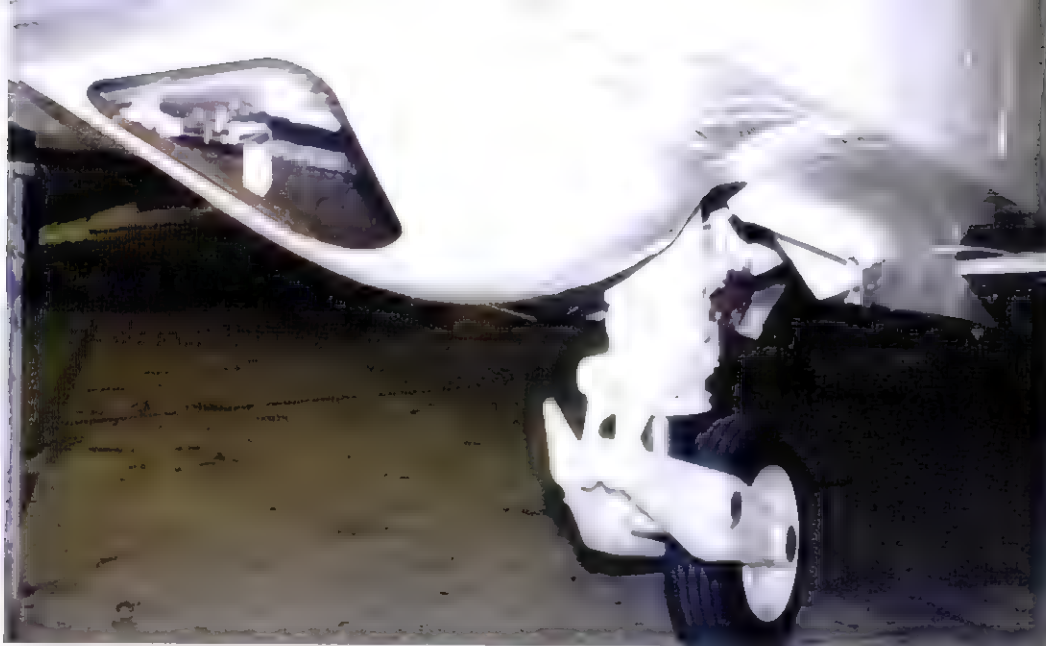
Mounts for either KB-10 or KA-15 series oblique cameras are seen through camera station 1's forward window. These cameras were mounted at a forward oblique depression angle of either 10°, 15°, or 25°, which was not adjustable in flight. This camera station was only utilized for day missions. (Author)

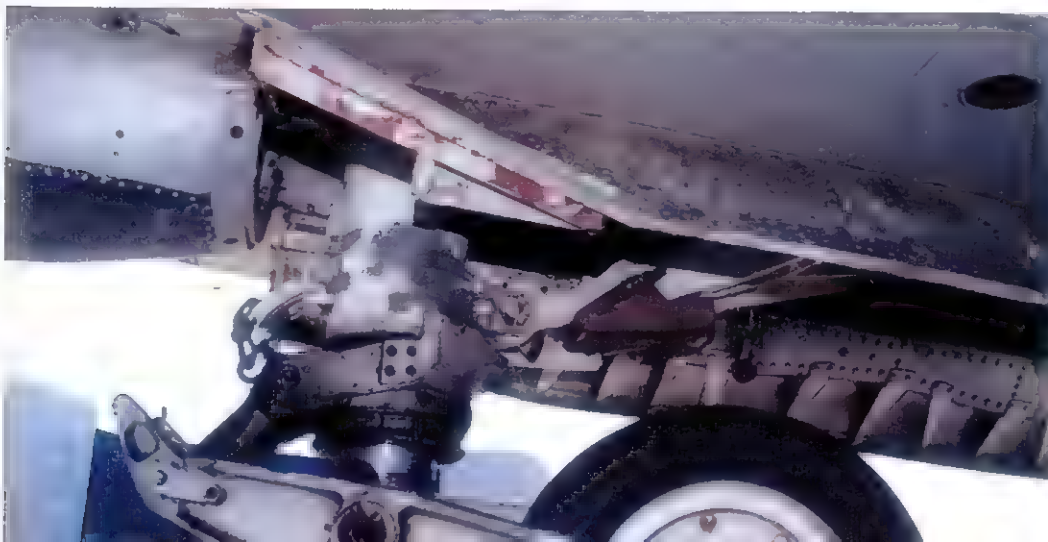
The RF-8's nose landing gear development followed the same progression as on the F-8 fighters. This RF-8G has fully extended the later style gear, which is easily identified by the 'skid horns' mounted on the front of the upper gear strut section. A yellow anchor painted high on the strut indicated where to place a chain for securing the aircraft to the ground or carrier deck. (Trombecky)
